## 4. Structural Systems Performance

*The dominant causes of structural failure observed by the MAT included storm surge, waves, floodborne debris, and wind. Structural damage due to erosion was also common on the barrier islands. Damage occurred to residential buildings (single- and multi-family housing), commercial buildings, and critical and essential facilities.*

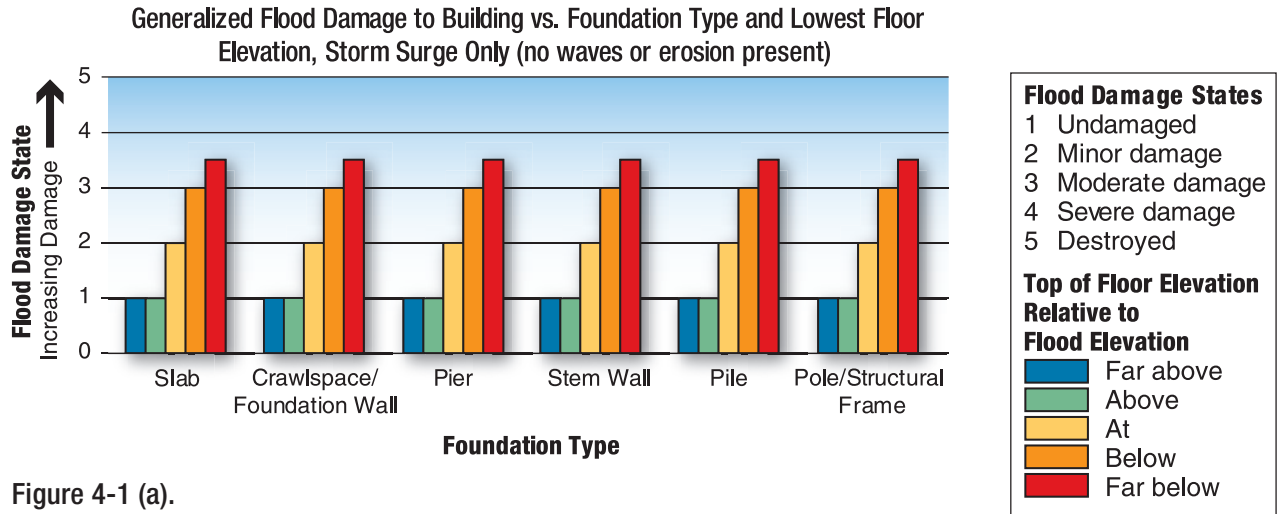
Figure 4-1 (a).

- Figure 4-1(a) shows observed damages for the case where inundation by storm surge occurred, but where waves and erosion were not present. In this case, damage tends to vary by floor elevation and be similar for all foundation types, as long as buildings are firmly attached to their foundations, buildings with the floor elevation far above the surge elevation tend to be undamaged and, as the floor elevation drops relative to the surge elevation, damage increases. This scenario is representative of much of the New Orleans area and in the areas of coastal Alabama and Mississippi where buildings are distant from the shoreline, and waves have dissipated.

Flood damage vs. foundation type and floor elevation (no waves or erosion)

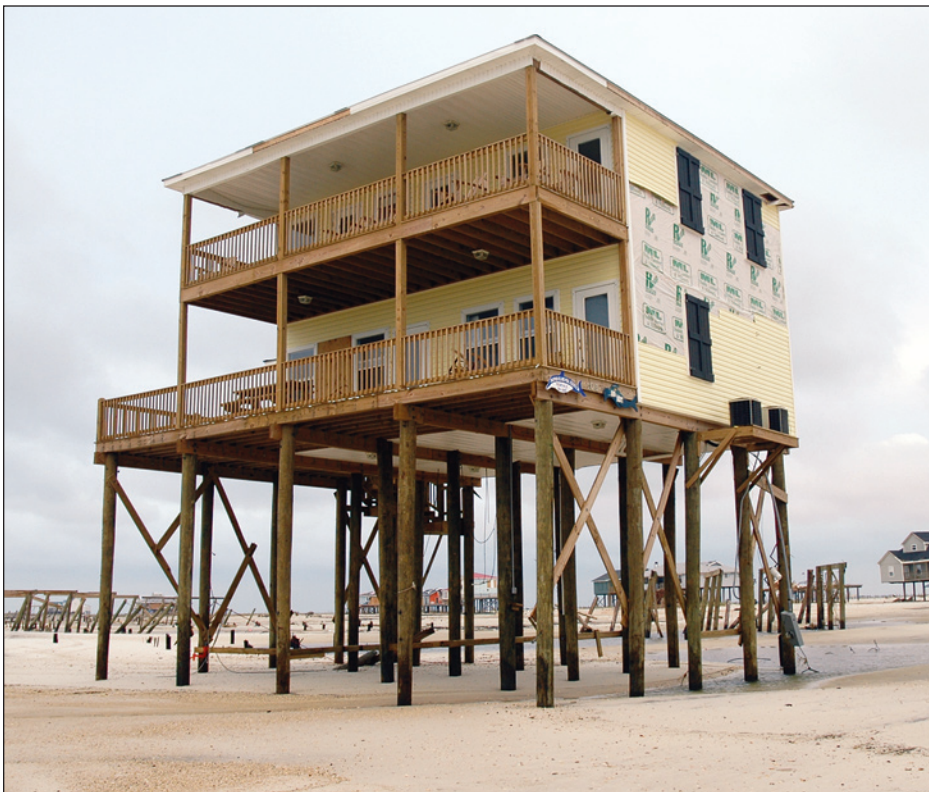
Figure 4-4.  
Another successful  
example of well-elevated  
and embedded pile  
foundation following  
Katrina. Note adjacent  
building failures where  
foundations were not  
high enough or where  
pile embedment was  
inadequate (Dauphin  
Island, Alabama).

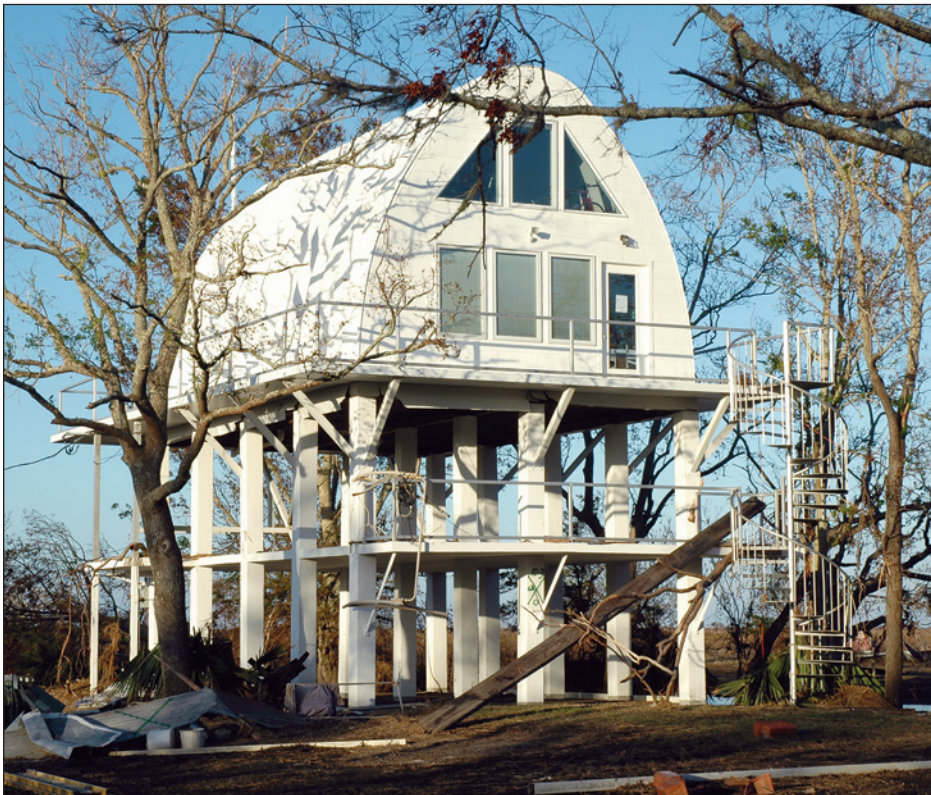
Figure 4-9.  
Successful house on  
high pile foundations,  
well above the local BFE  
(Shell Beach, Louisiana)

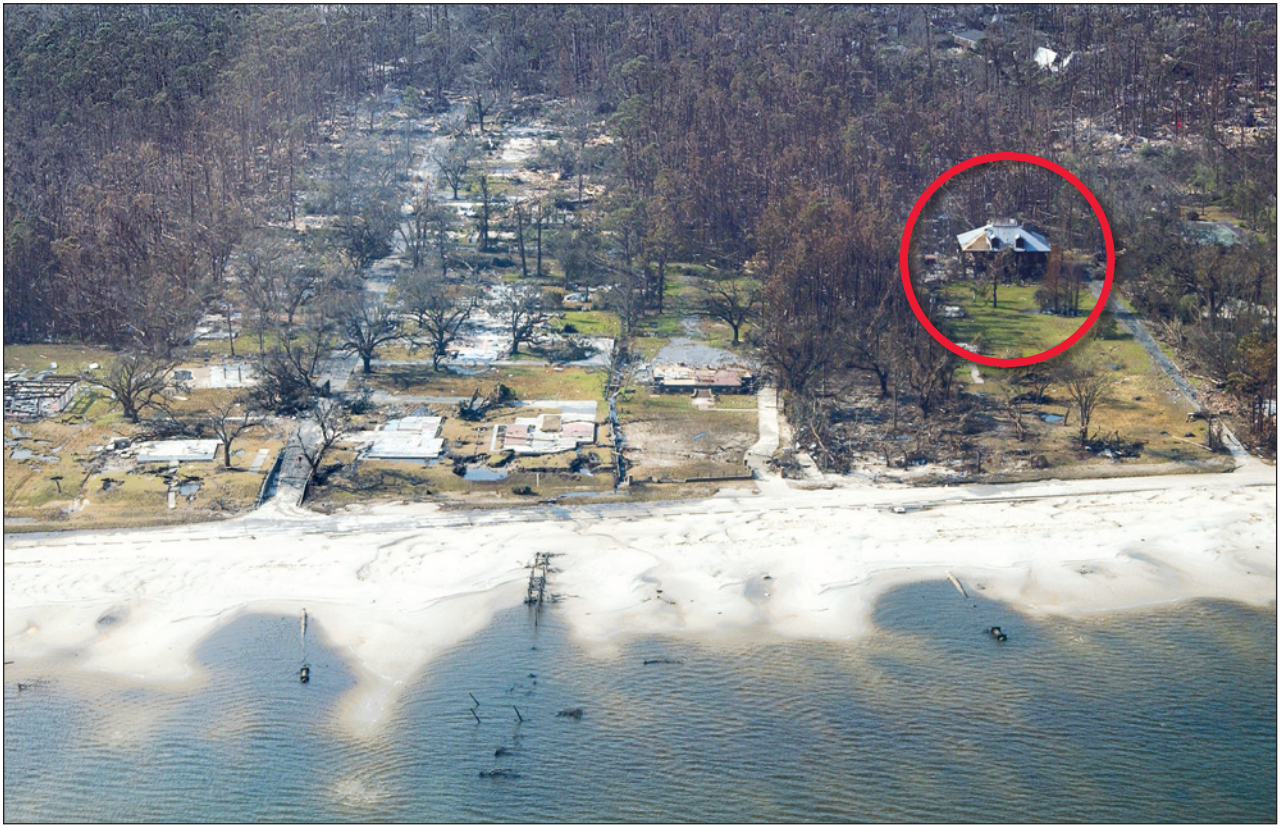
Figure 4-12.

Aerial view based on USGS imagery of the surviving pole constructed house shown in Figures 4-13 and 4-14 (circle). Note the many slabs and foundation remnants of destroyed houses nearby (Waveland, Mississippi).

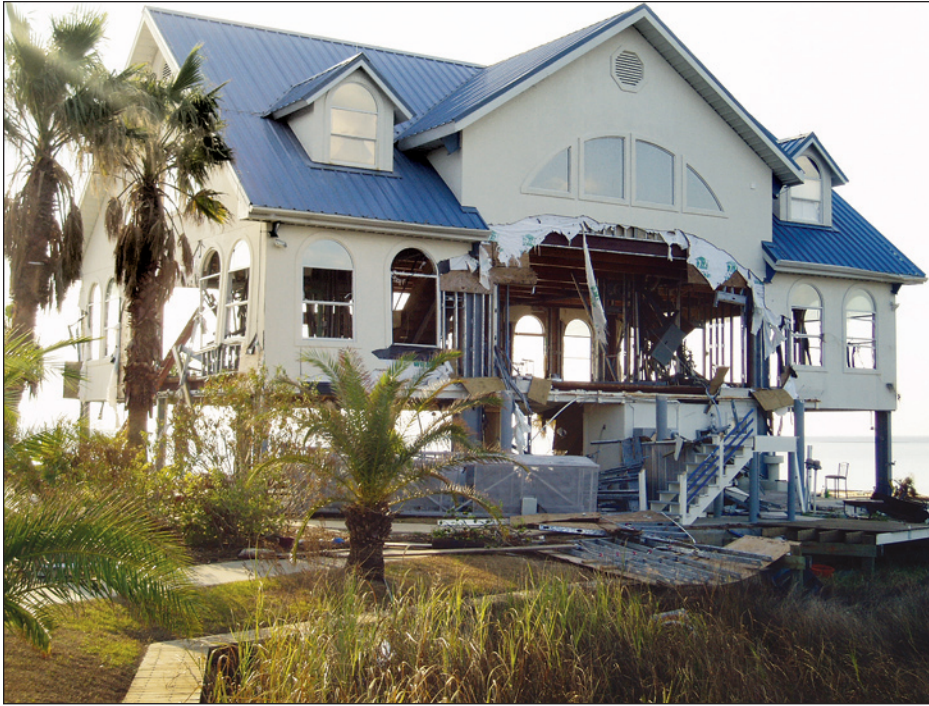
Figure 4-15.  
Steel-framed building on  
St. Louis Bay survived  
storm surge and wave  
action above the  
elevated floor level (Pass  
Christian, Mississippi)

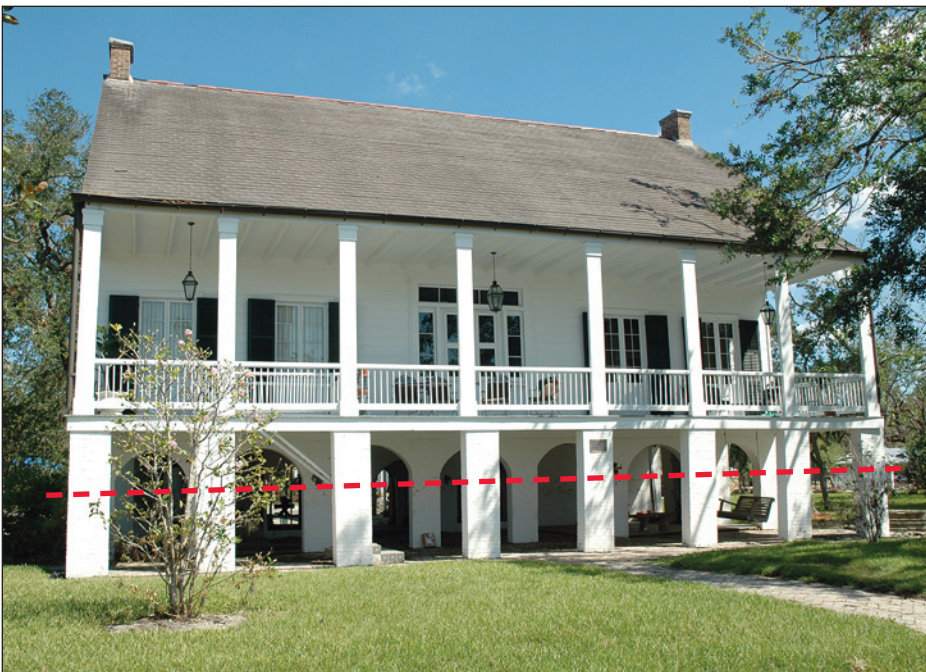
Figure 4-23.  
This 100-year-old  
building is on the  
National Register of  
Historic Places. It  
sustained minimal flood  
damage due to elevation  
on taller piers (an  
architectural choice, not  
a requirement when the  
building was constructed  
in 1905). Note the  
estimated flood depth in  
relation to the first floor  
(red line) (Mandeville,  
Louisiana).

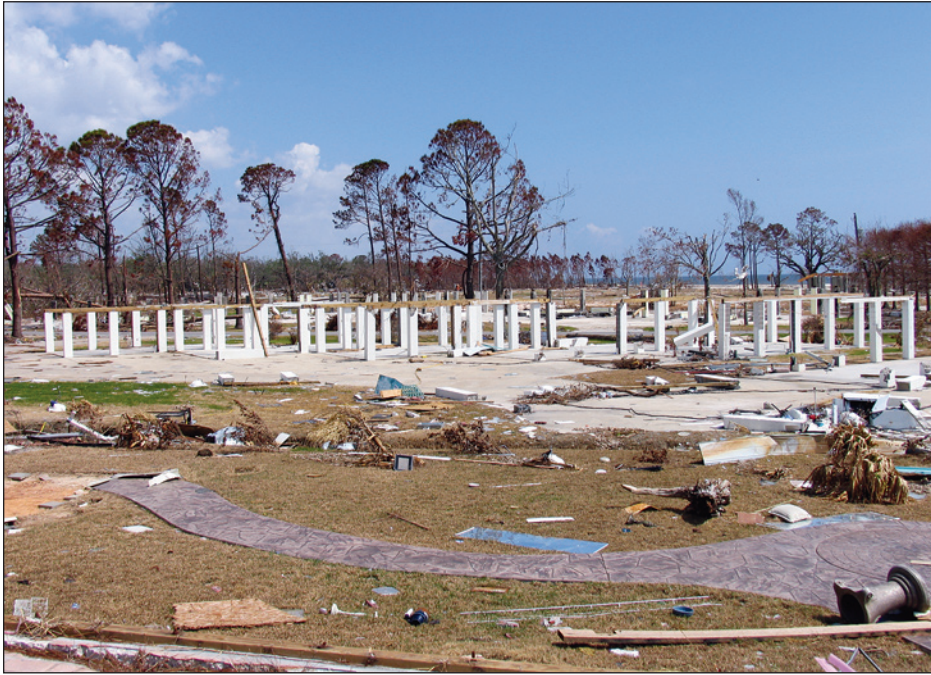
Figure 4-25.  
Another typical example  
of building failures  
when surge and waves  
exceeded pier foundation  
height (Long Beach,  
Mississippi)

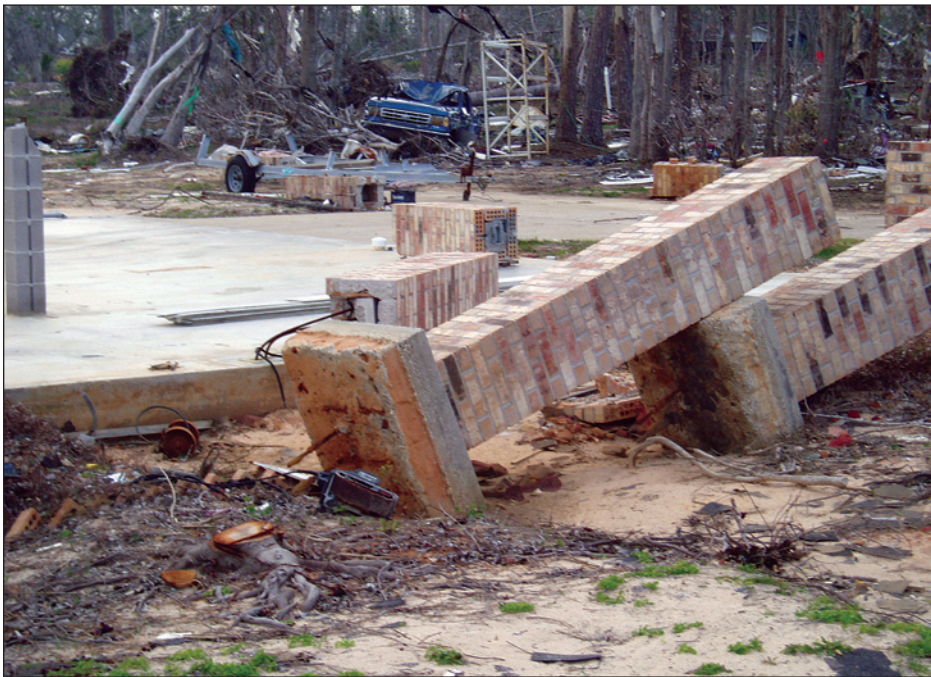
Figure 4-26.  
Failure of masonry piers  
on shallow footings (Pass  
Christian, Mississippi)

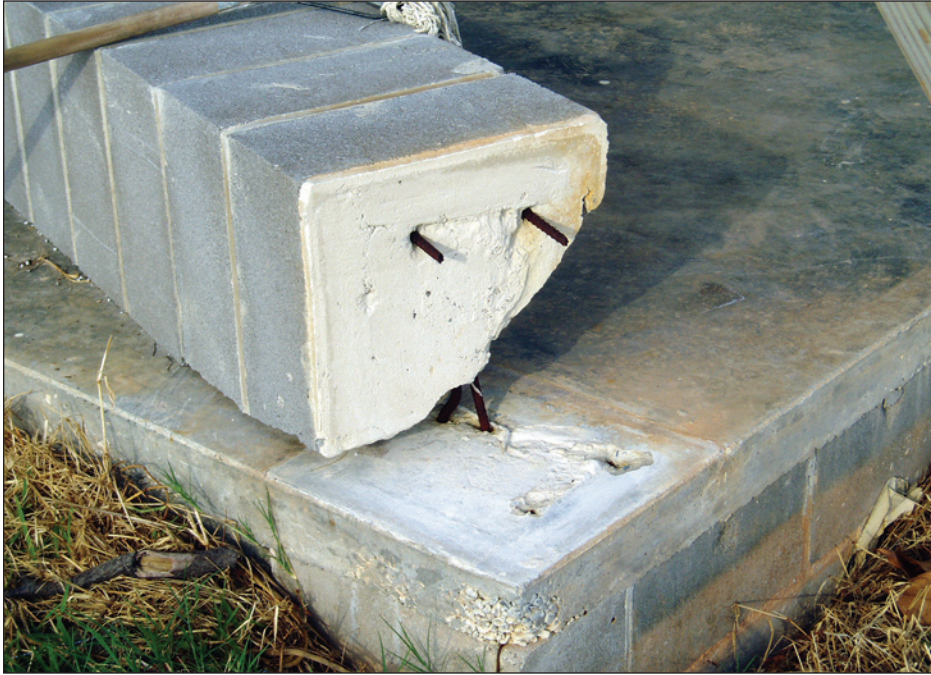
Figure 4-28.  
Pier connection failure  
(Belle Fontaine Point,  
Jackson County,  
Mississippi)

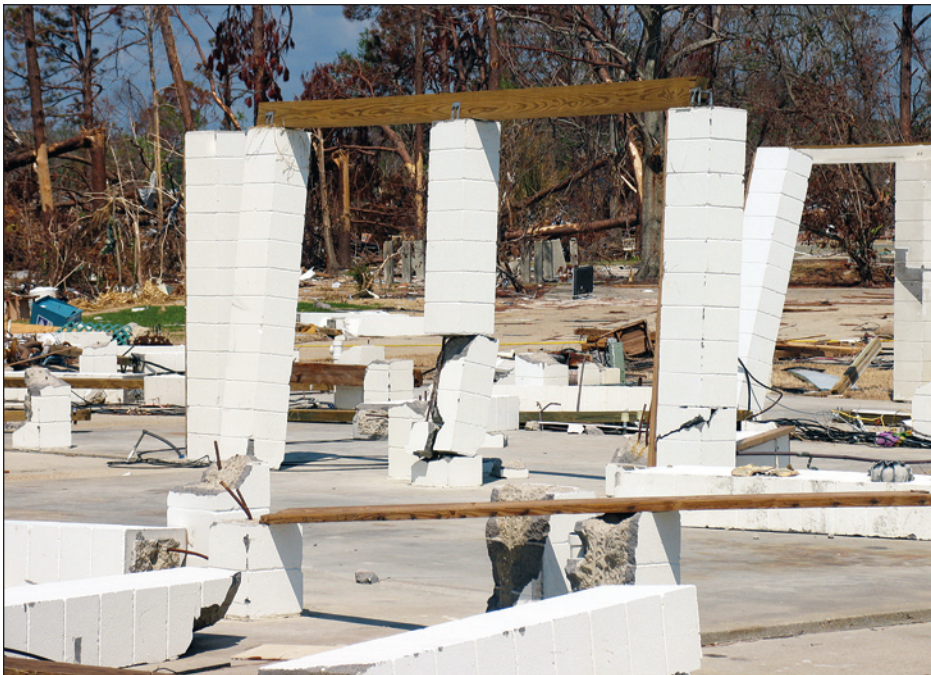
Figure 4-29.  
Pier breakage (Long  
Beach, Mississippi)

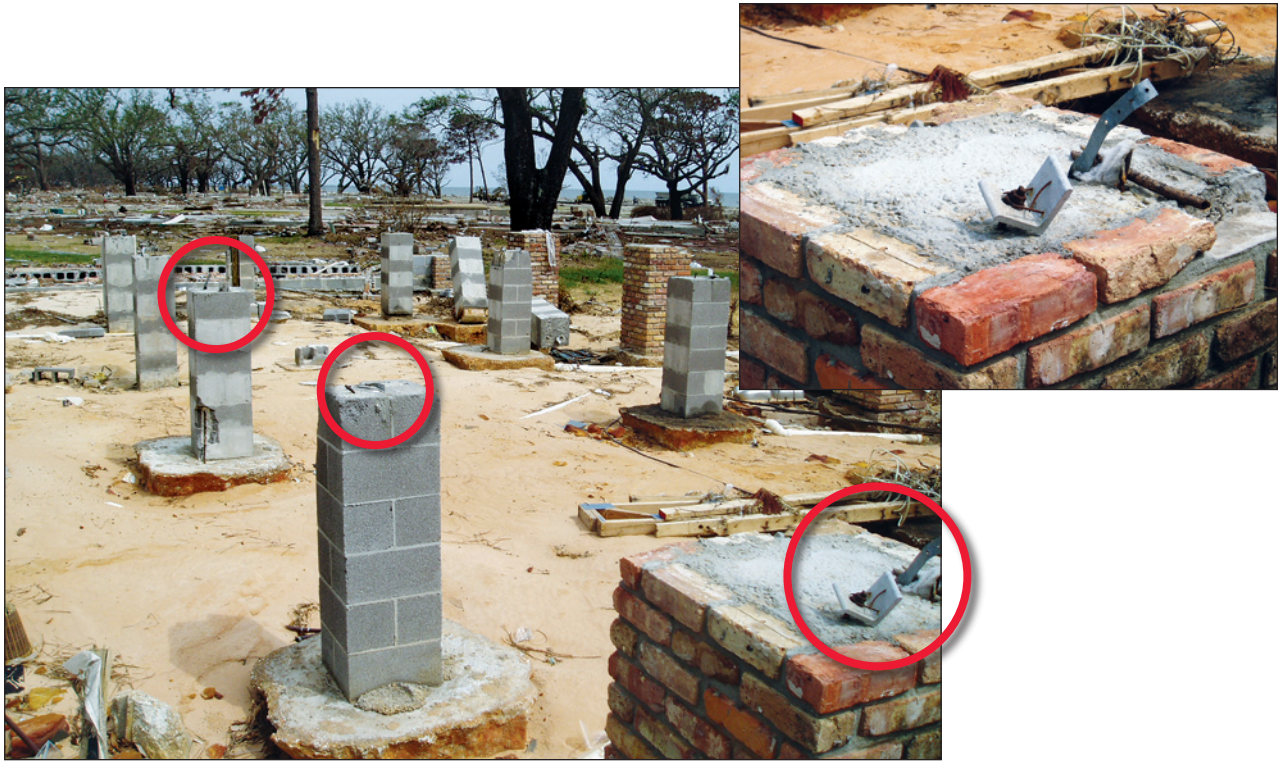
Figure 4-31.

Failure of pier-to-beam connections due to wave and flood forces acting on the elevated building (Long Beach, Mississippi)

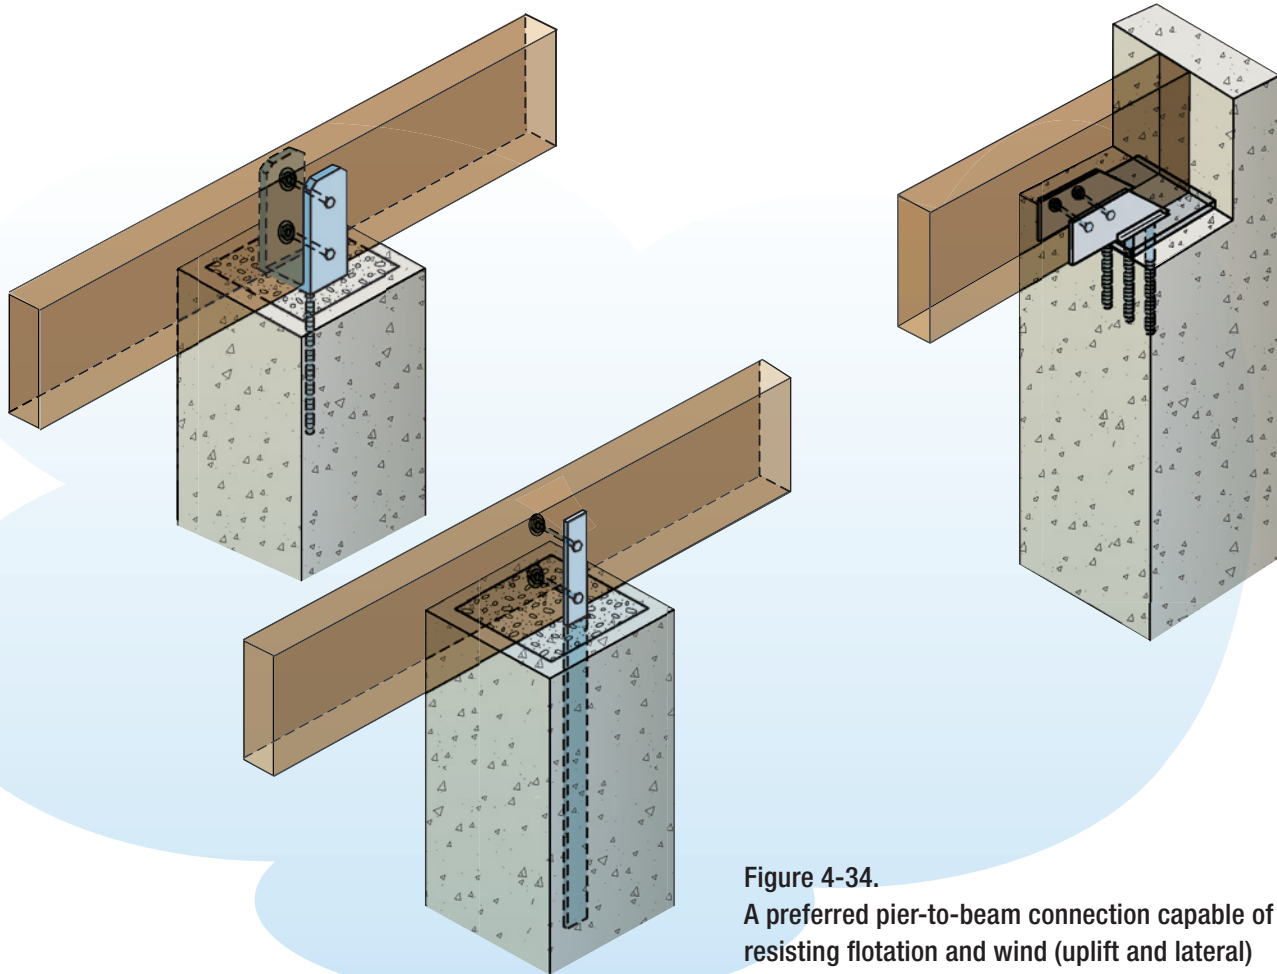
Figure 4-34.  
A preferred pier-to-beam connection capable of resisting flotation and wind (uplift and lateral) loads can be made using heavy beam seats.

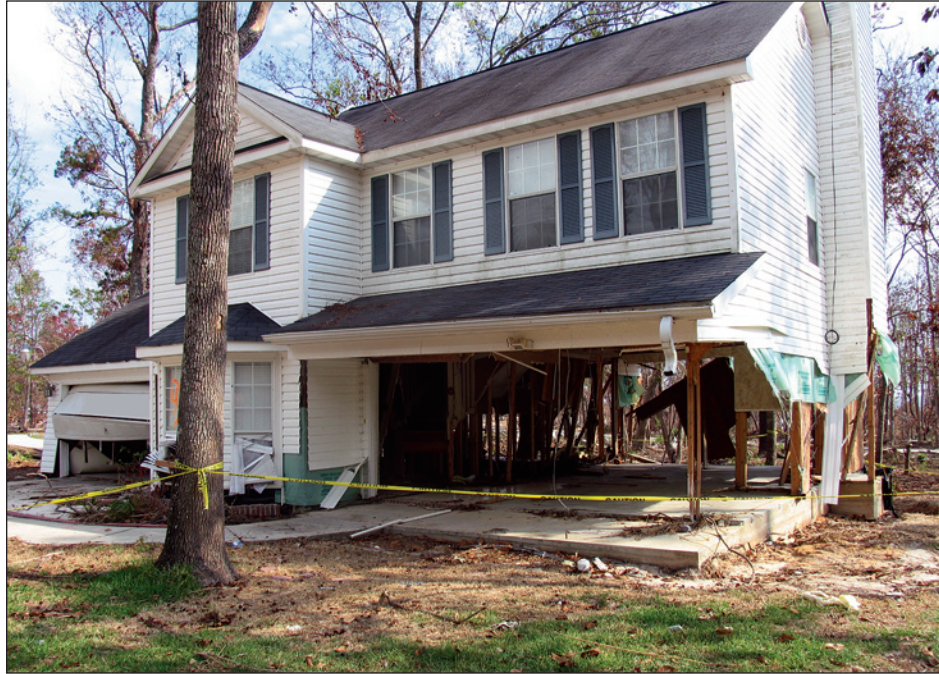
**Figure 4-37.**  
Waves, surge, and floating debris destroyed many single-family homes on slab foundations. Note debris from houses washed landward into other buildings (Biloxi, Mississippi).

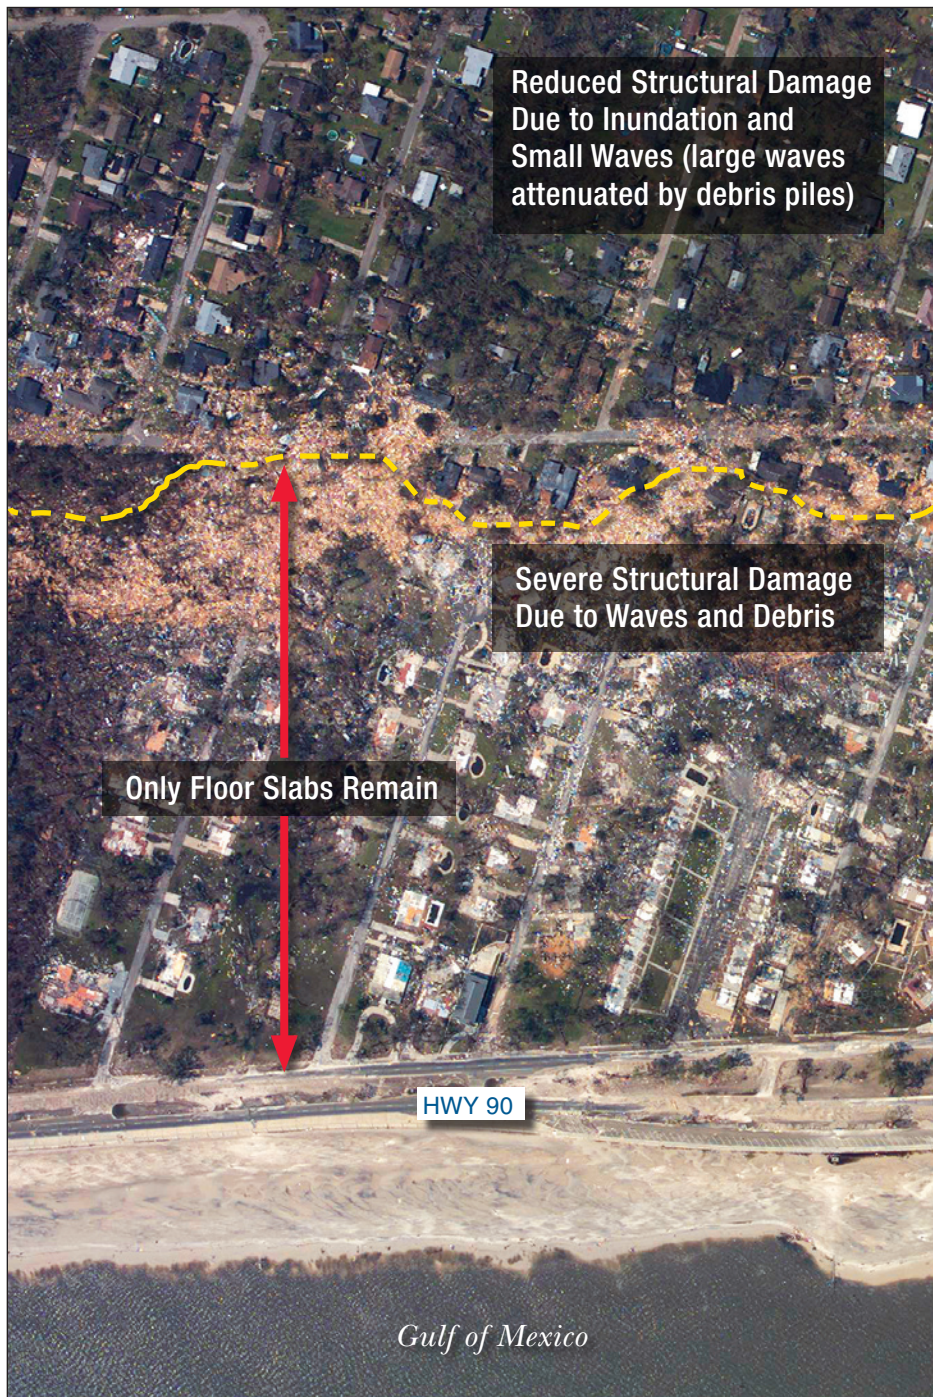
Figure 4-38.  
Typical zones of damage to homes supported on slab-on-grade foundations (Pass Christian, Mississippi)

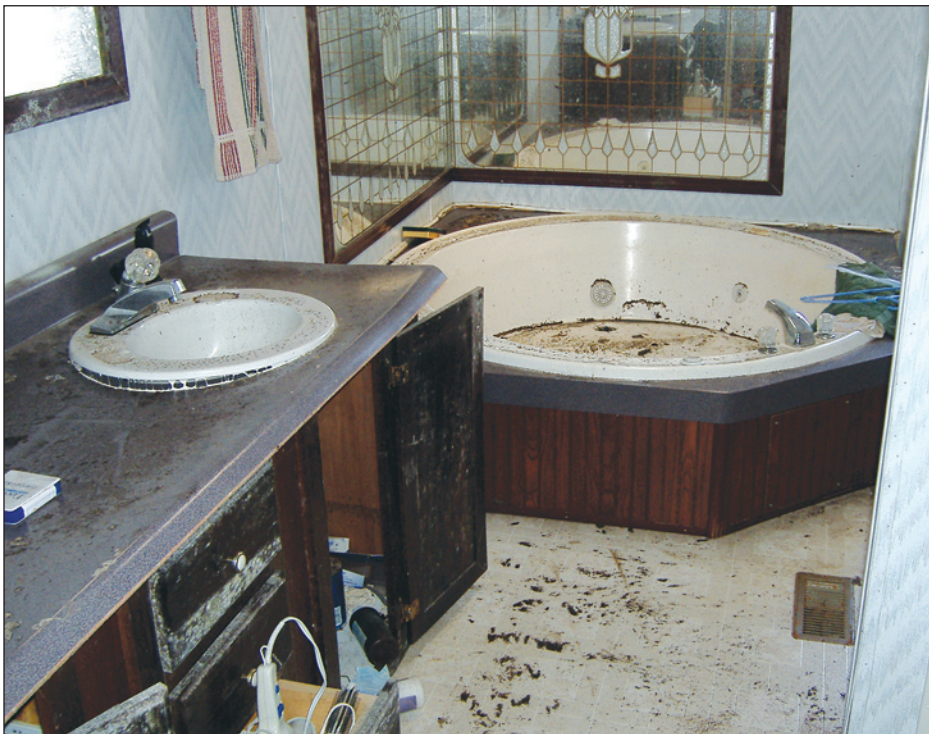
**Figure 4-44.** Interior photo of manufactured home shown in Figure 4-43 (Ocean Springs, Mississippi)

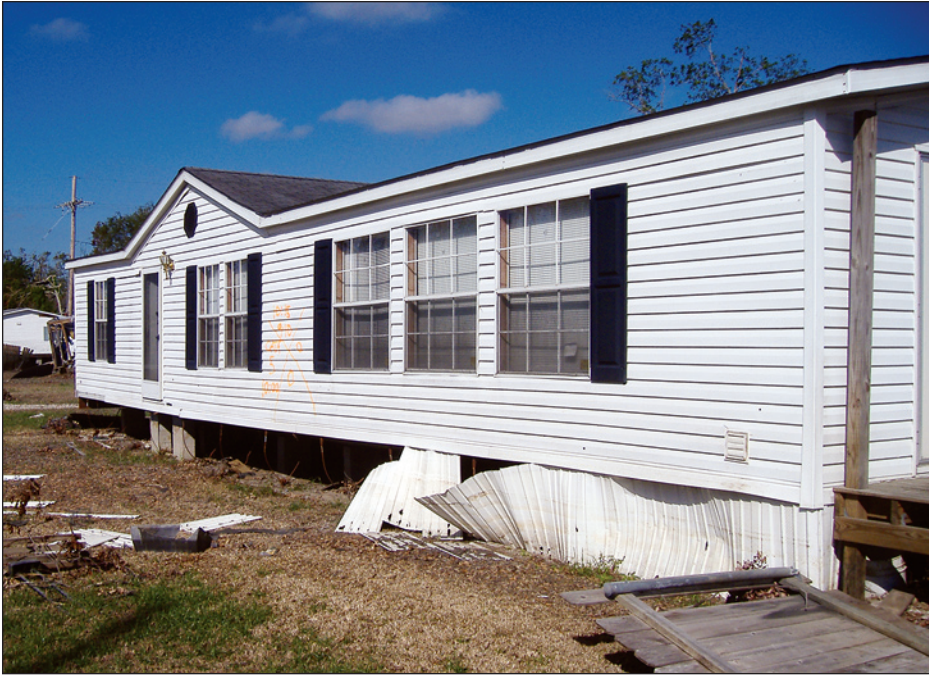
Figure 4-47.  
Flood-damaged  
manufactured home (St.  
Bernard Parish, Louisiana)

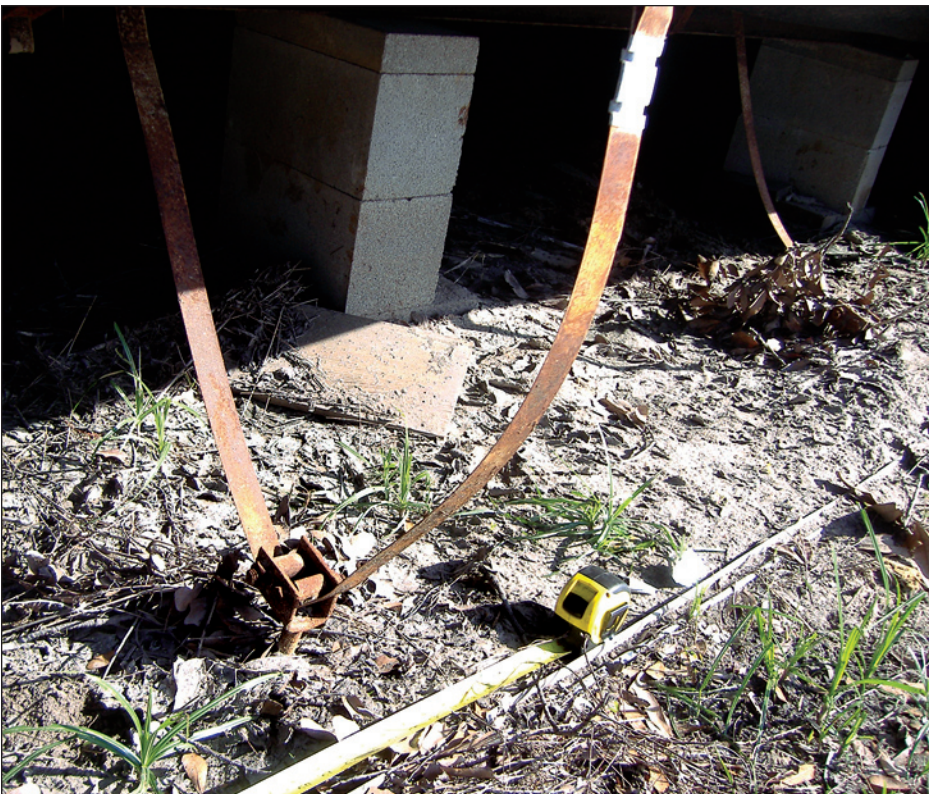
Figure 4-48.  
Foundation of home  
shown in Figure 4-47.  
The flood level rose  
above the floor, the  
ground anchors were  
apparently pulled up from  
the saturated soil, and  
the piers were displaced  
(St. Bernard Parish,  
Louisiana).

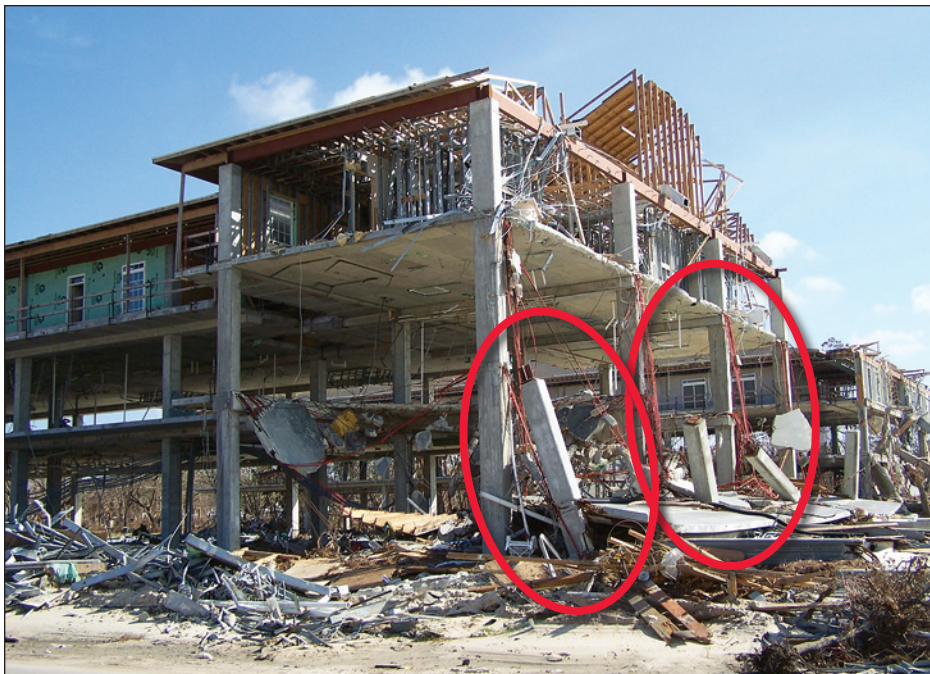
Figure 4-61.  
Multi-family property on  
Beach Boulevard with  
failed post-tensioned  
slabs and columns. Note  
the post-tensioning  
tendons (circles) (Pass  
Christian, Mississippi).

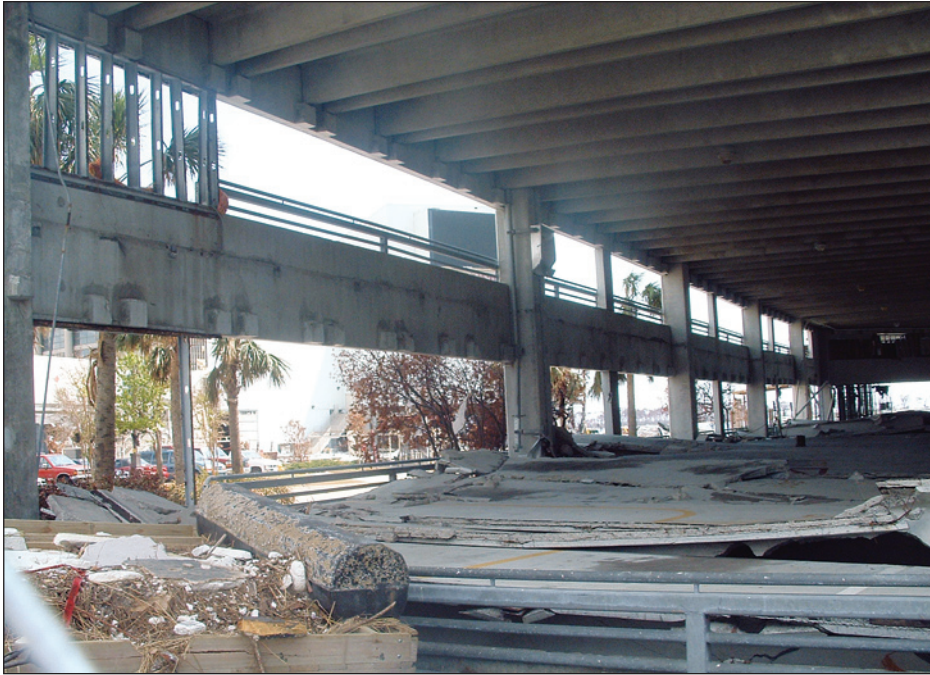
Figure 4-64.  
Collapse of first elevated level of pre-stressed parking decks due to poor column-to-beam gravity connections that failed when exposed to lateral and uplift wave forces (see Figure 4-65) (Biloxi, Mississippi)

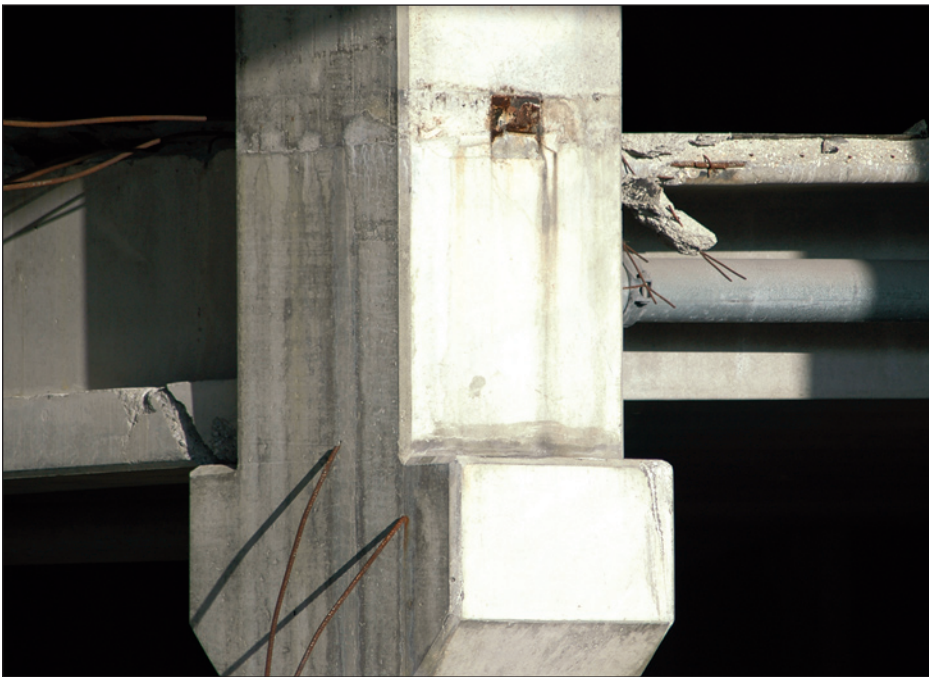
Figure 4-65.  
Another view of the collapse of first elevated level of pre-stressed parking decks shown in Figure 4-64 (Biloxi, Mississippi)

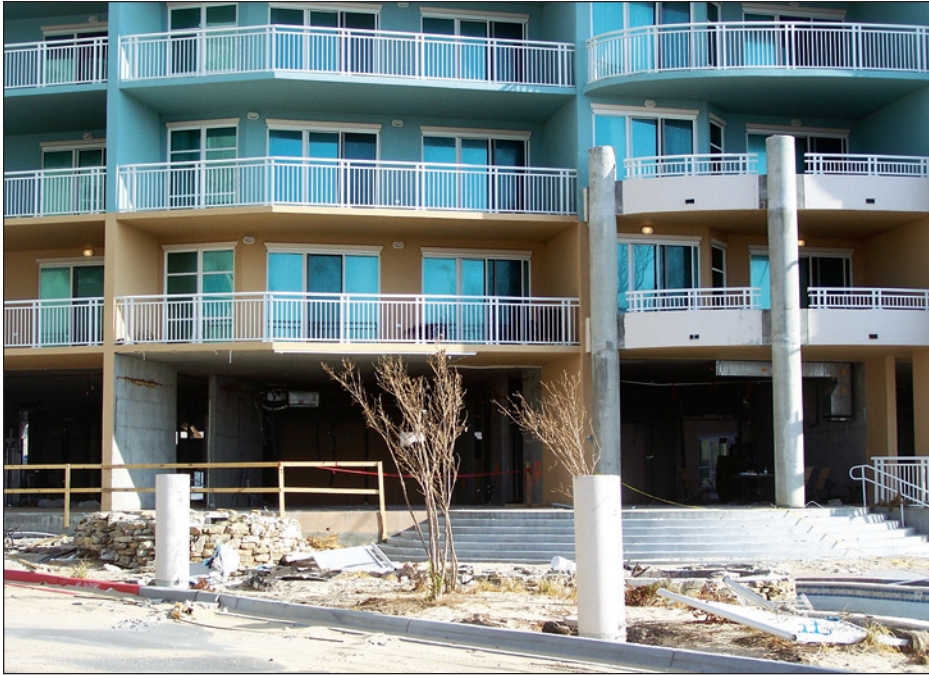
Figure 4-68.  
Another view of the  
high-rise building along  
Beach Boulevard shown  
in Figure 4-67 (Gulfport,  
Mississippi)

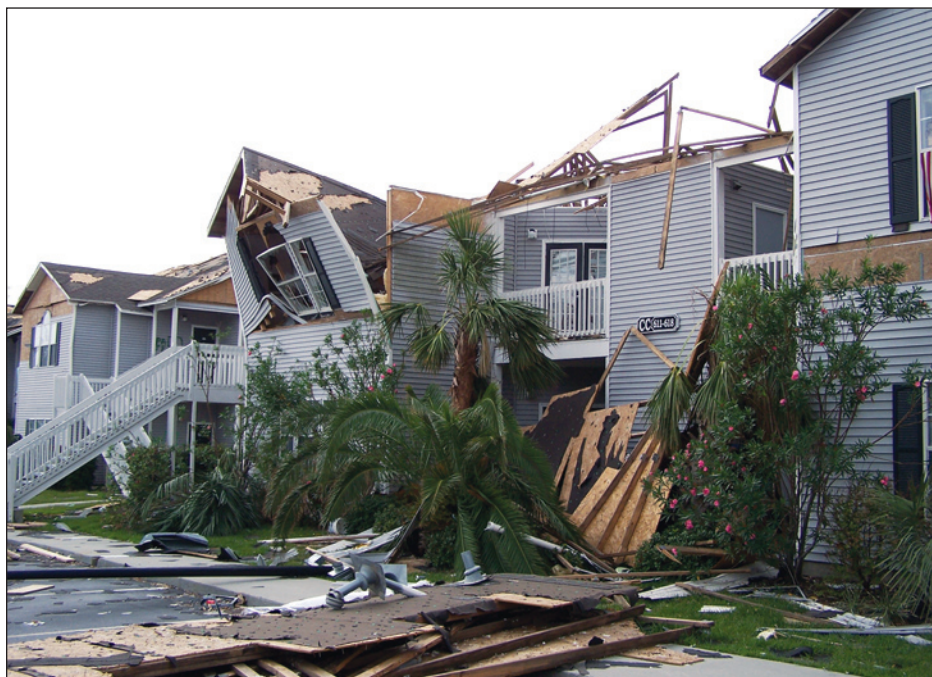
Figure 4-74.  
Two-story apartment  
building that lost its roof  
diaphragm and load path  
connections  
(estimated wind speed:  
120 mph. Ocean Springs,  
Mississippi)

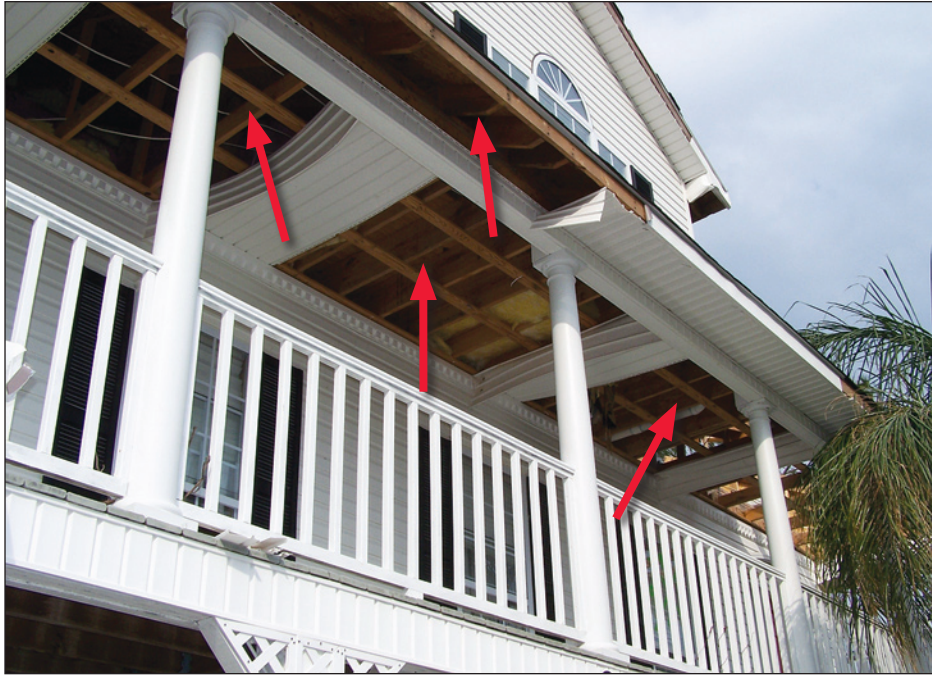
**Figure 4-77.** High pressures under overhangs often lead to progressive structural failures. Note the vinyl soffit material removed by high-wind pressures (arrows) (estimated wind speed: 130 mph. Pass Christian, Mississippi).

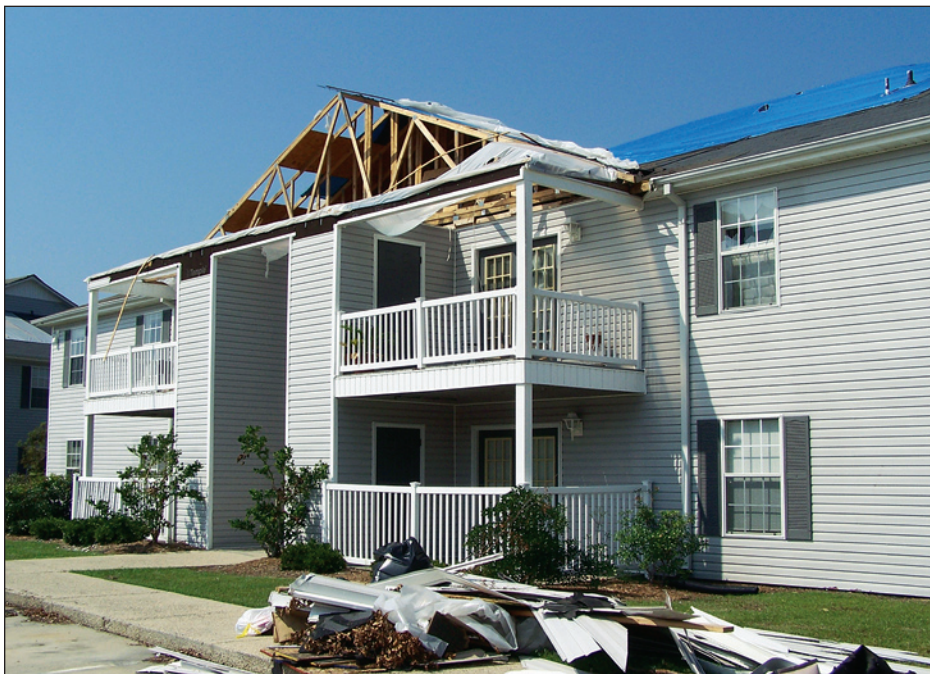
**Figure 4-78.** Pressurization of the second floor porch ceiling of this apartment led to soffit failure and loss of roof decking and other structural components (estimated wind speed: 120 mph. Ocean Springs, Mississippi).

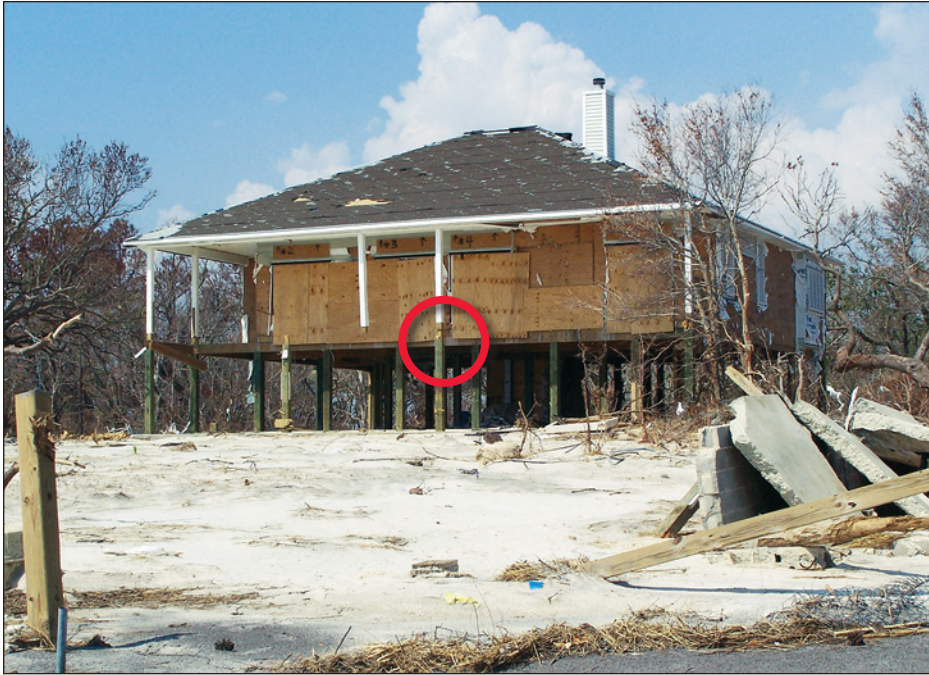
Figure 4-80.  
Coastal home located in Exposure C received significant surge damage into the habitable level and, although it lost its porch and three porch columns, the basic load path remained connected. Red circle indicates location of Figure 4-81 (estimated wind speed: 120 mph. Ocean Springs, Mississippi).

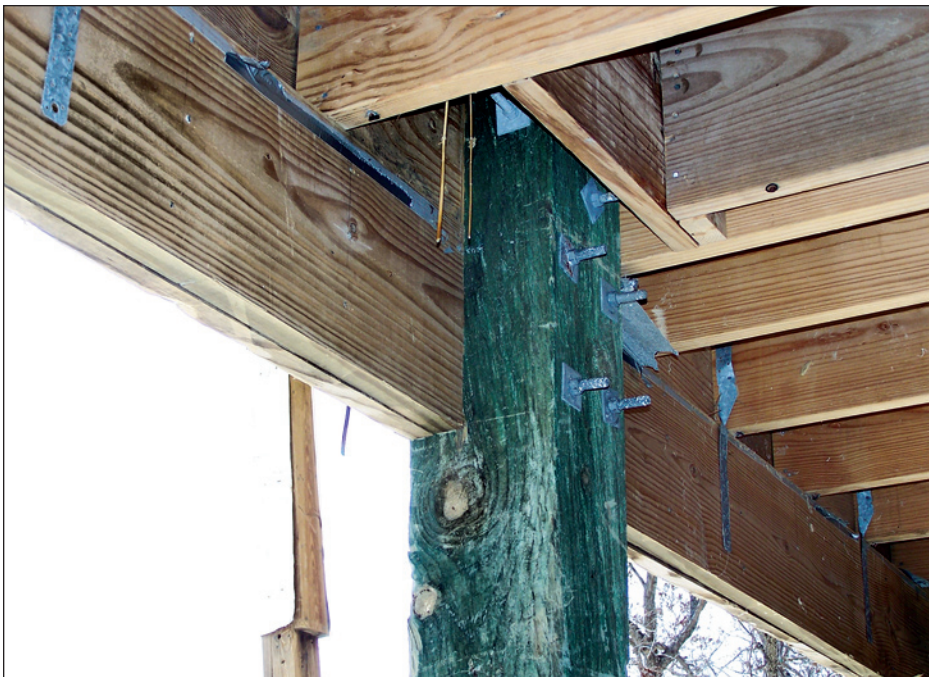
Figure 4-81.  
Coastal home located in Exposure C that is well connected with beam-to-column lap joints and galvanized bolts and straps (estimated wind speed: 120 mph. Ocean Springs, Mississippi)

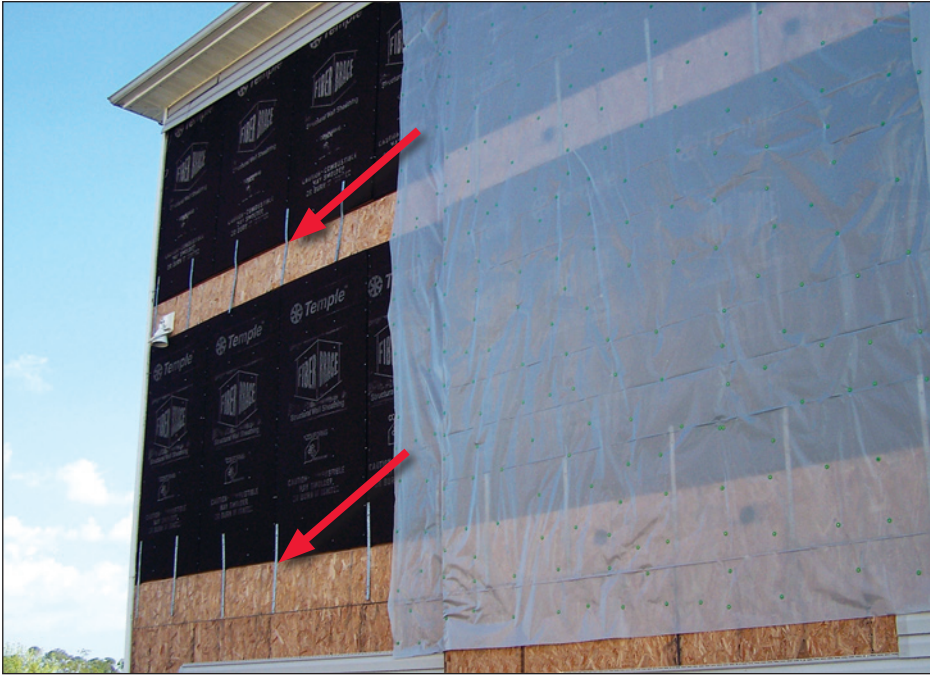
Figure 4-84.  
Two-story structure with floor-to-floor connectors (arrows) that are adequately spaced, but improperly attached (see Figure 4-83) (estimated wind speed: 120 mph. D'Iberville, Mississippi).

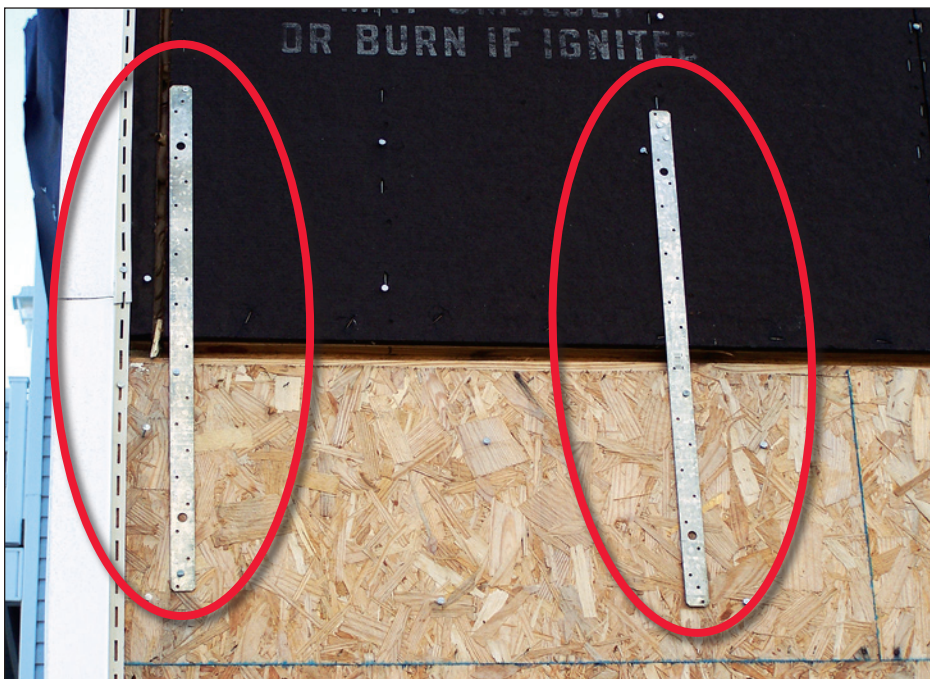
Figure 4-85.  
Two-story structure with floor-to-floor connectors that were adequately spaced, but were too short to extend into the wall framing above and below the floor level and were missing several fasteners (circles) (estimated wind speed: 120 mph. D'Iberville, Mississippi).

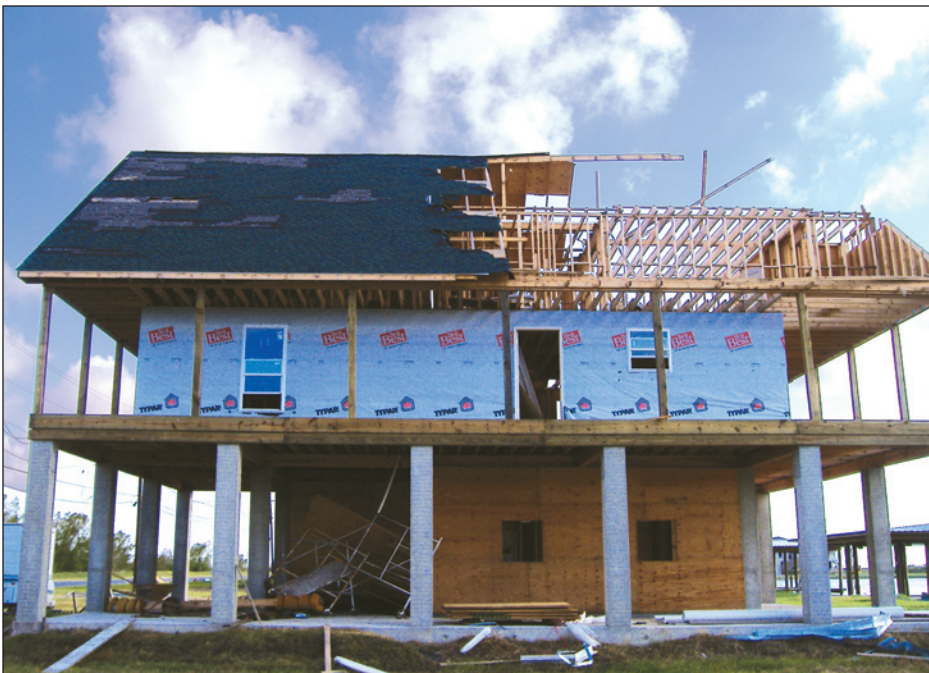
Figure 4-89.  
Home located in Exposure C that lost portions of its roof structure (estimated wind speed: 110 mph. Plaquemines Parish, Louisiana)

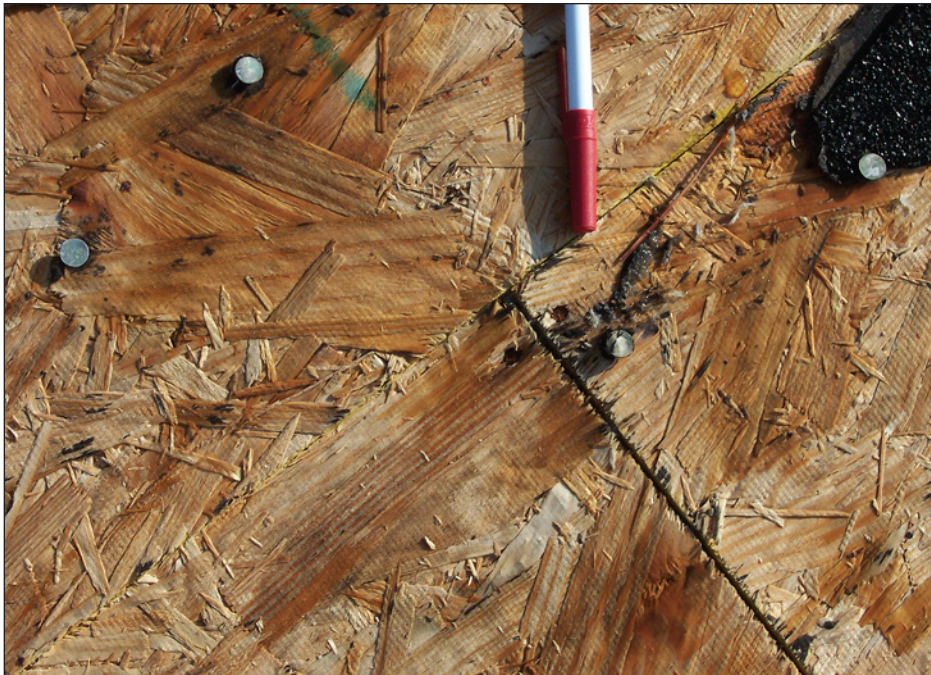
Figure 4-92.  
Roof sheathing nailed  
only at corners, and  
stapled in other areas  
(estimated wind speed:  
130 mph. Long Beach,  
Mississippi)
